PROJECT CASE STUDY

Trees Court, St. Peter's Road Selsey

The Refurbished Roof at Trees Court

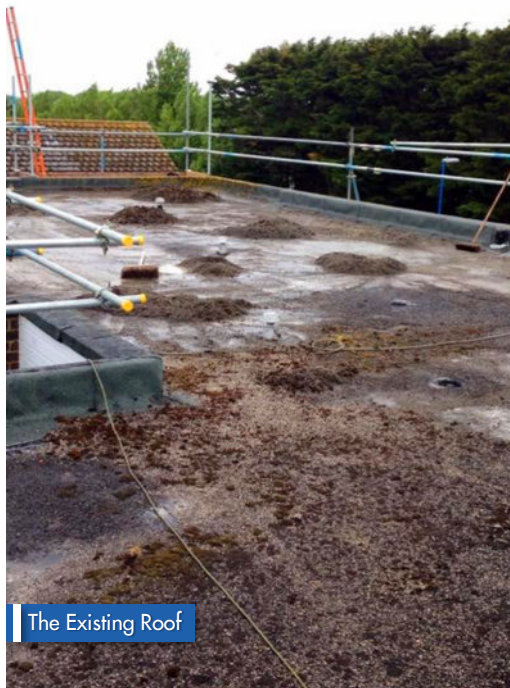
The Existing Roof

The existing roof needed to be cleaned of all the existing dirt and debris, ready for the application of new waterproofing. However, despite best efforts by the Premier Contractor to reach a level substrate, it was not possible.

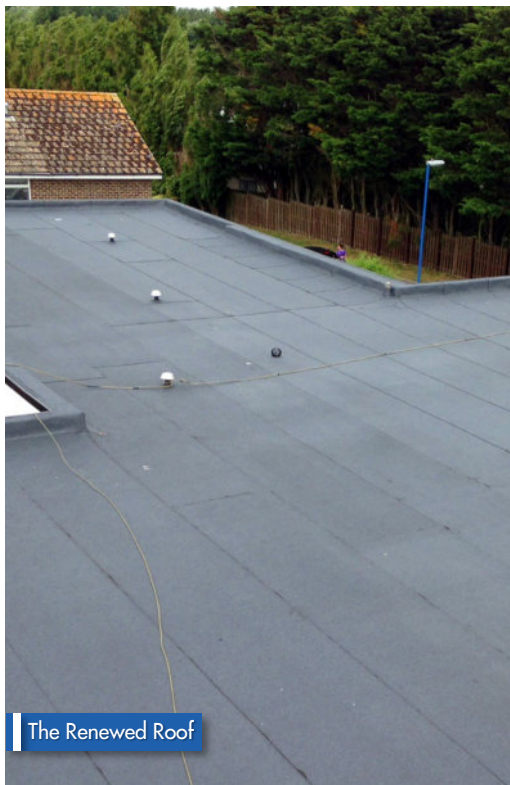
The Renewed Roof

For this application we recommended our STONEWOOL Recovery Board, an A1 non-combustible mineral wool insulation board for flat roofing applications. This board provided a level surface and improved external fire performance and suited the clients budgets.
